# Old Moor Farm, Wombwell (RSPB)

## Historic Buildings Report

by David Cook (Yorkshire Vernacular Buildings Study Group)

December 2022

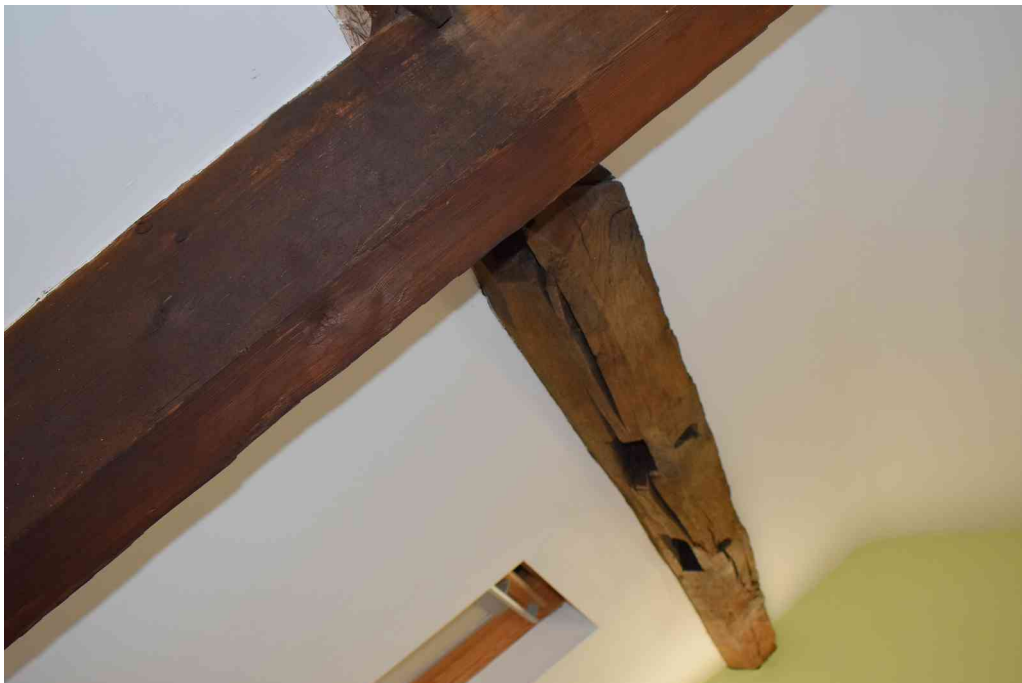
There are two principal rafters supported on the wall tops with no apparent tie beam (but see photos section). This wide span roof has three sets of purlins, all with tusk tenons, most of purlins reused, most likely from a timber framed building. Many empty mortices are angled on one side indicating that they are for braces but not in this roof structure. A purlin on the east (E) end of the roof in conference room 'Swallows Nest', has one angled for a brace, next to a mortice for stud/post and then another hole for a brace on opposing side, each held by a single peg (See figs. 4 & 5).

Figure 5: Photo of timber reused as a purlin showing empty mortices and pegholes.(October 2022)

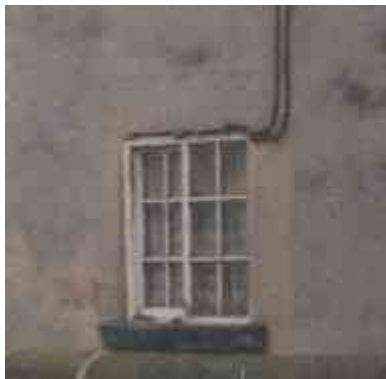
Photos of the house taken before and during renovation show that the walls were wholly rendered over. At the front, the door and window fittings are all 20<sup>th</sup> C and have been replaced along with the lintels (probably) and the cills, but are probably in their former positions. At the rear all the windows are similar replacements except for the ground floor E room which is a horizontal sliding sash of 2 x 6 lights (fig.7).

*Figure 7: House rear window (1995)*

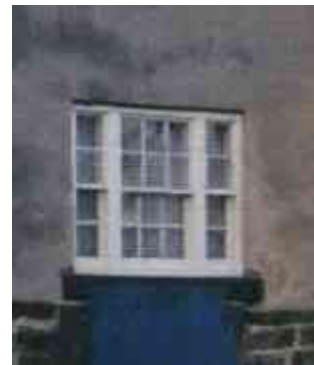
*Figure 8: 'Cottage' rear window (1995)*

**Photos of the cottage** show the S elevation rendered over and with the same windows as the house at the front. There is no window to the ground floor E room. The rear is also rendered over. Only the ground floor W window could be original with vertical sashes between 2 timber mullions (see photo above). The current window is a fair copy.

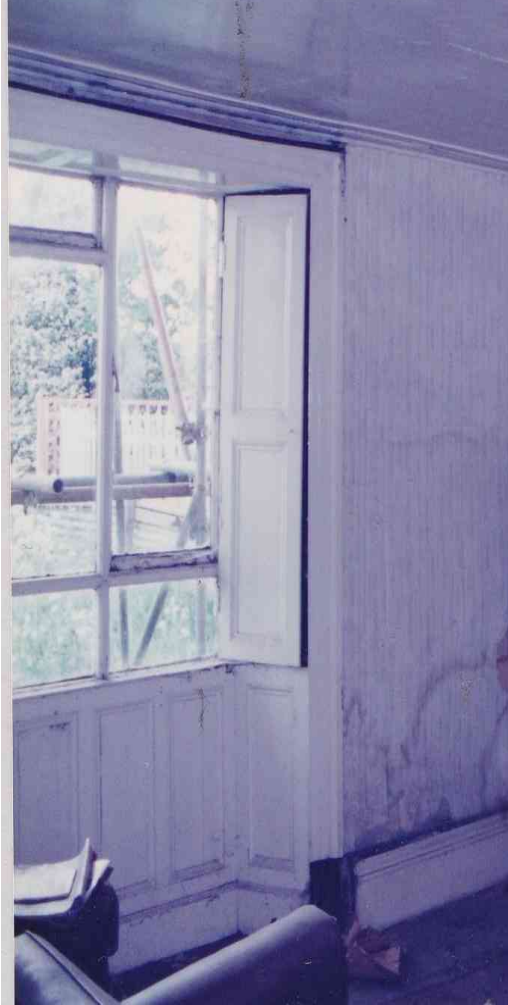
Internal photos don't reveal any features earlier than the 19<sup>th</sup> C. The fireplaces shown, for example, are blocked. A few features are of interest. The NE ground floor room has meat hooks from the ceiling. This room is plastered. There's also a wooden table and shelves against a chimney breast; the fireplace, obviously not in use. One of the front rooms has a walk-in window with panels below the window and 2-panel shutters in the reveals, possible early 19<sup>th</sup> C (fig.9).

*Figure 9: House walk-in window (1995)*

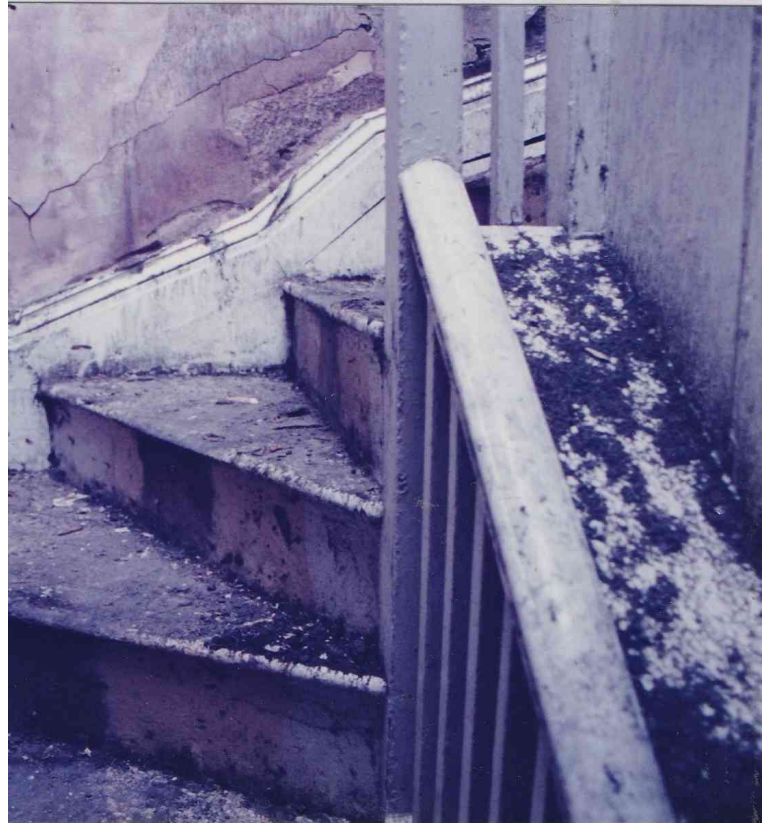
A photo of part of the stair shows it has stick balusters of the late 18<sup>th</sup> or 19<sup>th</sup> C (fig.10). Photos showing the roof reveal tie beams across the 2 principal rafters and a ridge but it's not clear how this engages with the apex of the principal rafters. All the common rafters have been replaced during renovation.

*Figure 10: House stair (1995)*

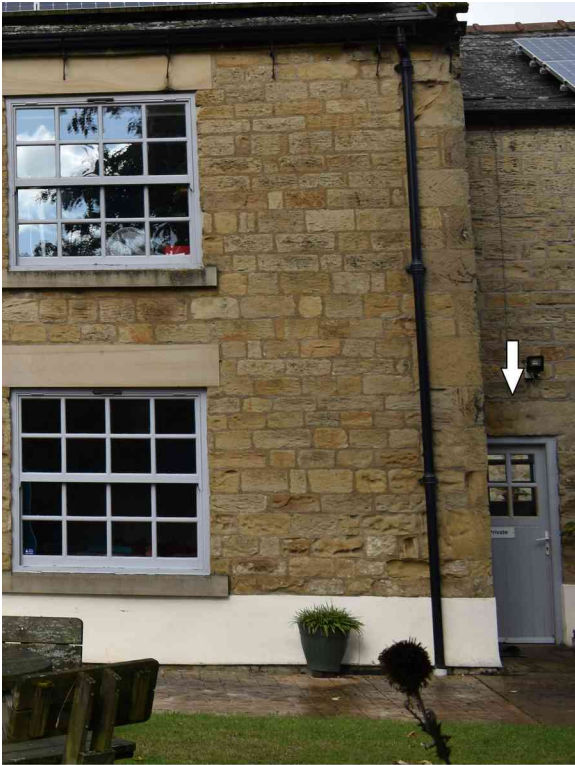
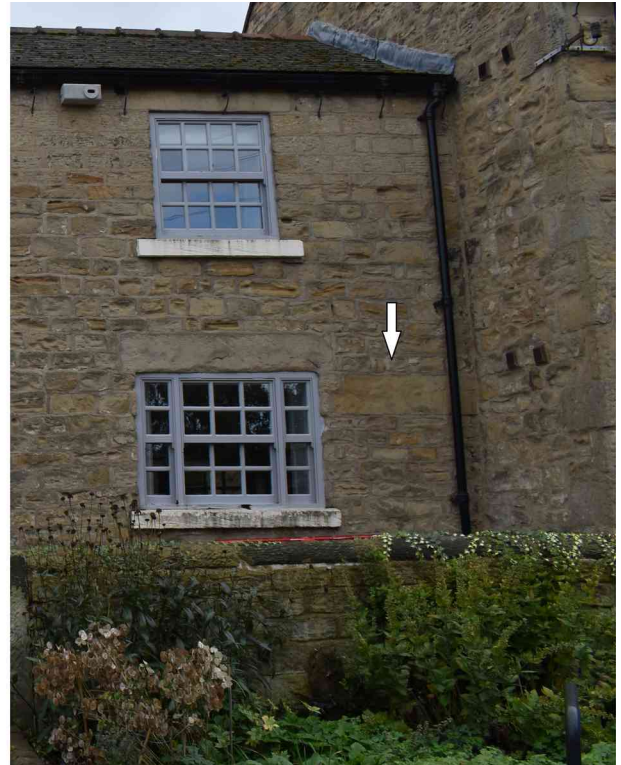
This is attached to the E side of the house. It is a narrower and lower building. The walls are of similar stonework to the house. The roof is also thin grey slate and of a shallower pitch to the house. There is an axial (slightly off centre) brick stack whose fireplace would have heated the W room. The front door is central, like the house, but it faces N. All the windows appear to have been replaced. There is a blocked door (lintel above still in place) on the N side next to the house, and a door opposite on the S side. This appears to have been for a cross-passage (fig.11).

*Figure 11: 'Cottage' cross-passage door from S (left) and N (right) (2022)*

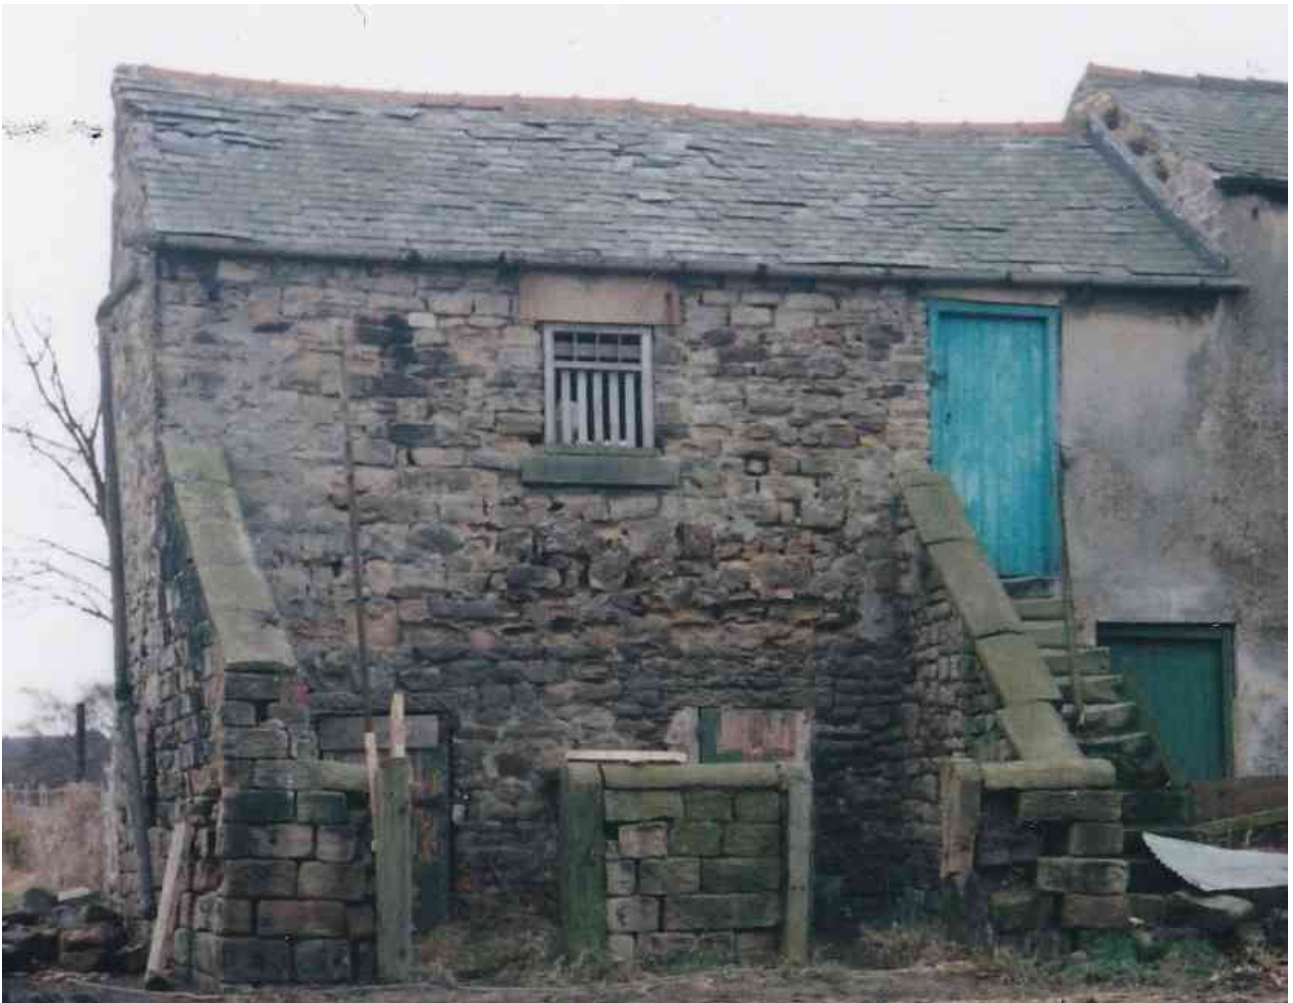
**Photos of this building** show that the S elevation as rendered over. It has a line of three small openings (ventilation?) and three vertical sash shape upper openings with sills as today, filled with a combination of louvres below and 4 small fixed lights above. The cross-passage door is there. The N elevation is mostly as it is today, except for the rendered area extends to the upper door, and the upper window was formerly a combination of louvres below and 4 small fixed lights above (fig.14).

*Figure 14: Store / Piggery N elevation (1995)*

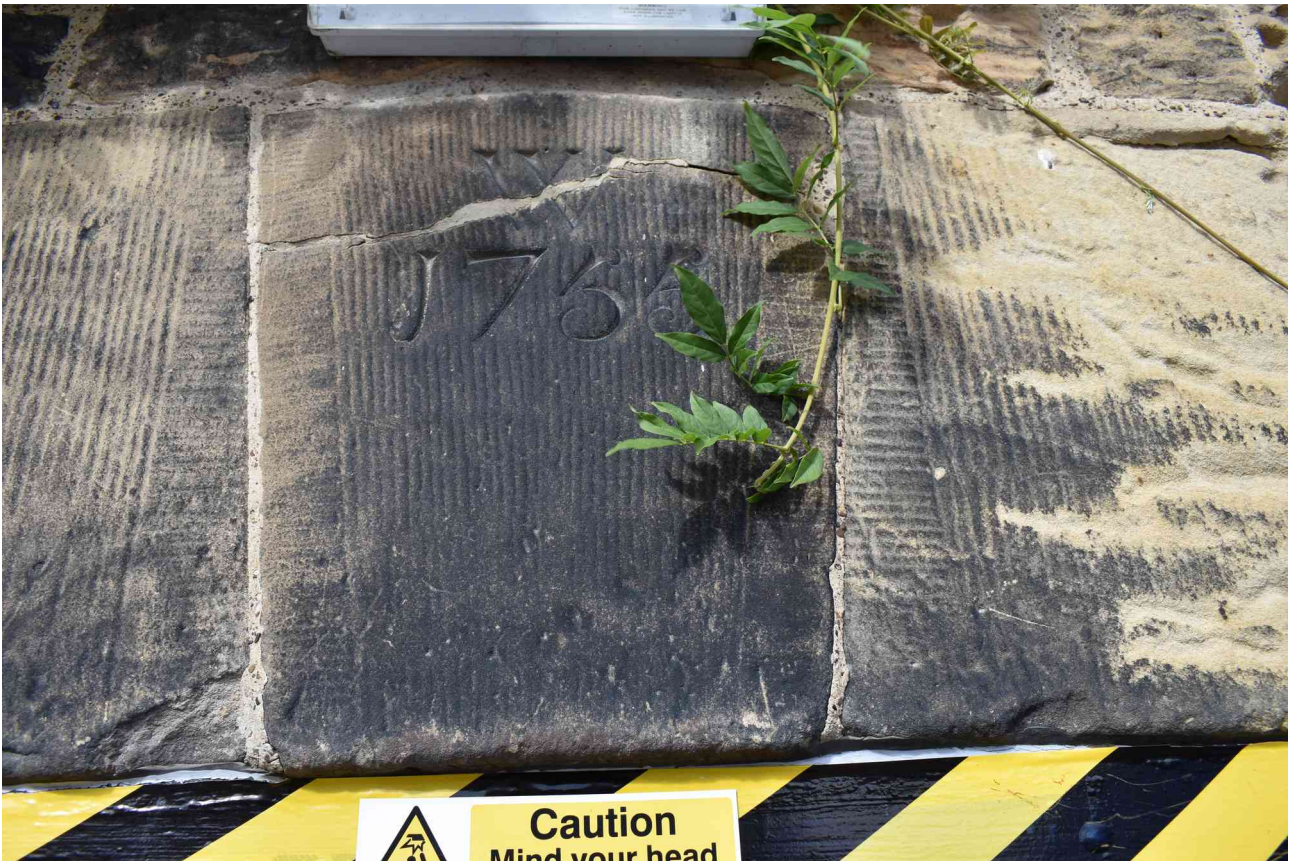
This is of six bays and forms the N side of the foldyard. Its walls are laid in courses of coal measures sandstone. There is a thin grey slate roof with coping stones and kneelers. In the centre of the S elevation is a wide but relatively low door. It has a very shallow arch lintel made up of a stone either side and keystone with the monogram 'W' (which presumably stands for 'Wentworth') and date of 1755. It has fine ribbed tooling with margins (fig. 15).

Figure 15: Barn datestone of 1755 (October 2022)

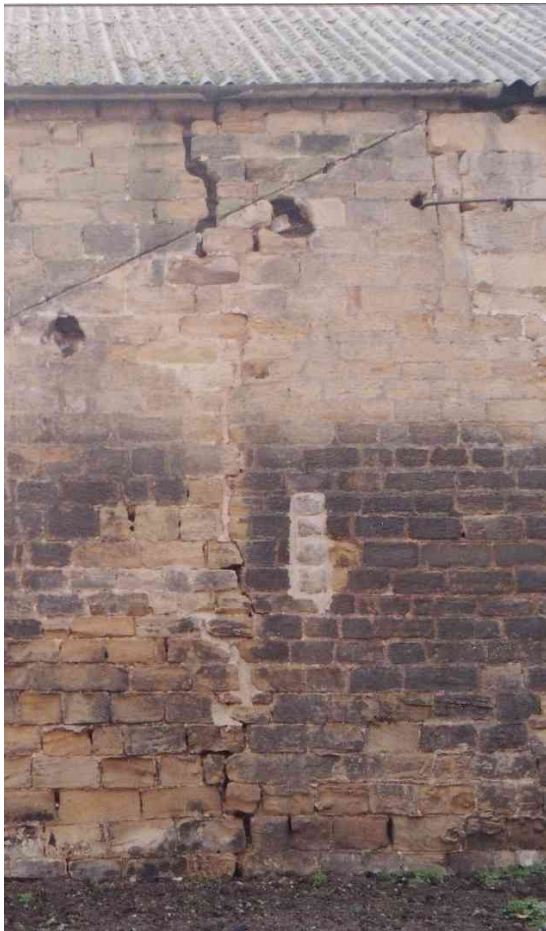
Near the E end of the N elevation is a jagged vertical crack in the masonry which follows the line of a straight joint. Although care has been taken to maintain the courses of stones, in one or two places, this hasn't been followed. It appears that the barn has been extended to the E by at least one bay (see fig.17). (This is backed up by the evidence from the E elevation where the adjoining stable block has the quoins on its side of the joint not on the barn side, fig.18).

*Figure 17: Barn N wall joint/crack (1995)*

This crack is covered by the 'shadow' of a very wide wing which even extends over half of the central door. There are big holes in the stonework for purlins and a groove cut for flashing. This shadow also covers an upper window, presumably for taking-in which itself has been partially blocked to leave a large ventilation slit. There are blocked slits lower down possibly for drive shafts or belts. There is no blocked door at ground floor level into this wing.

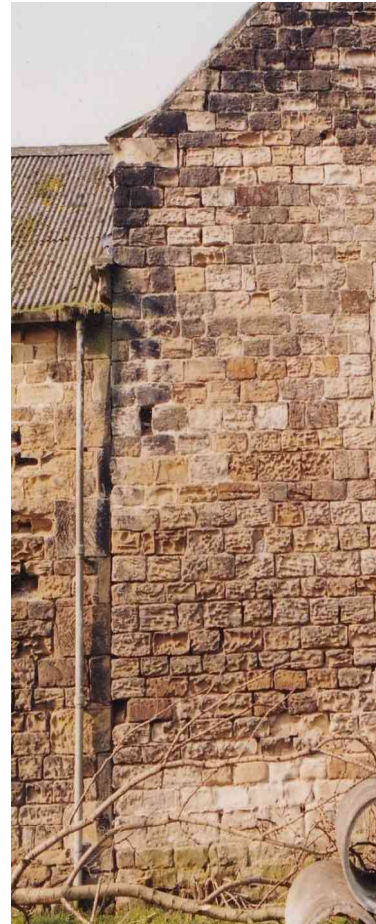
*Figure 18: Barn - Stable joint and quoins E elevation (1995)*

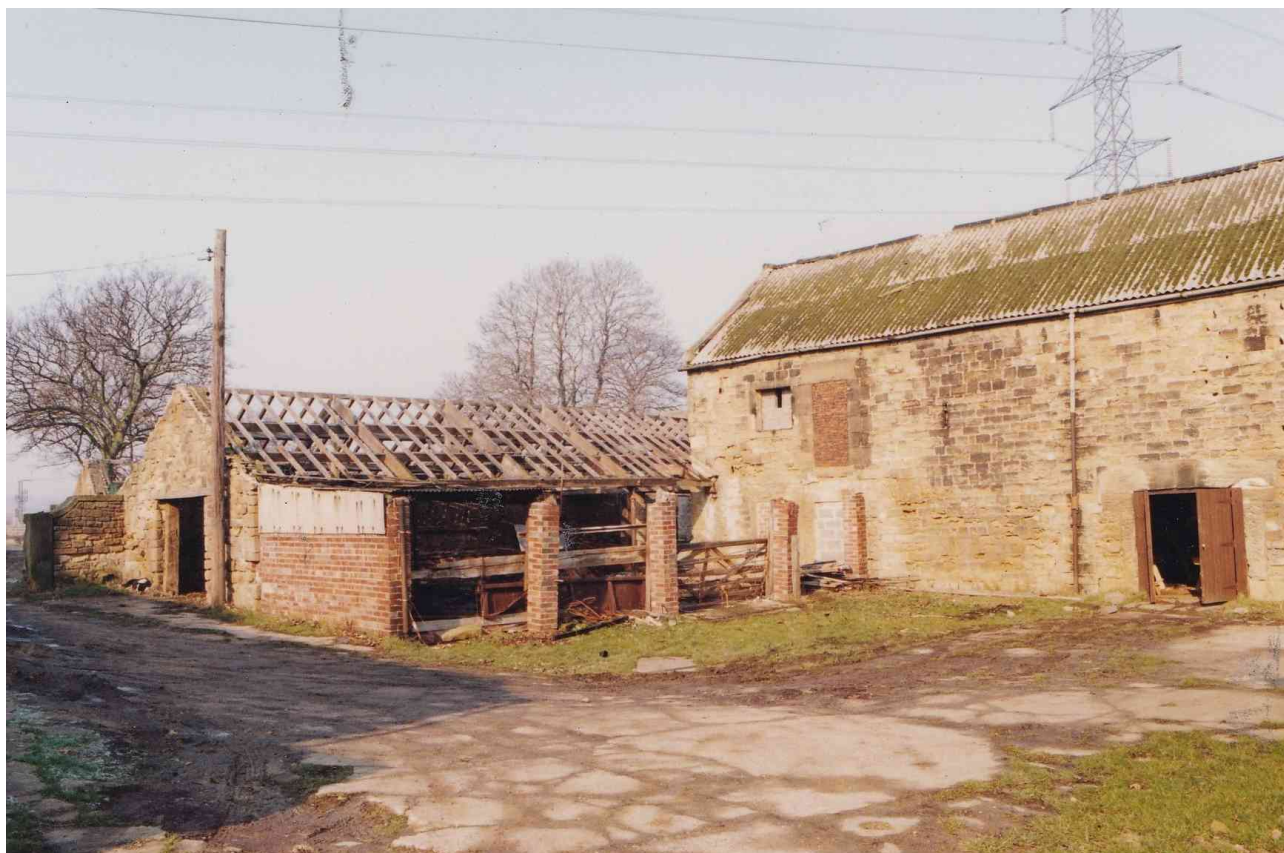
At the W end, the oldest photo shows the taking-in door blocked by brick and the entrance door blocked by breeze block. This was probably done when the open shed front was extended E into the foldyard. It was supported by square section machine cut brick piers (fig.19).

*Figure 19: W end of barn and cart shed (1995)*

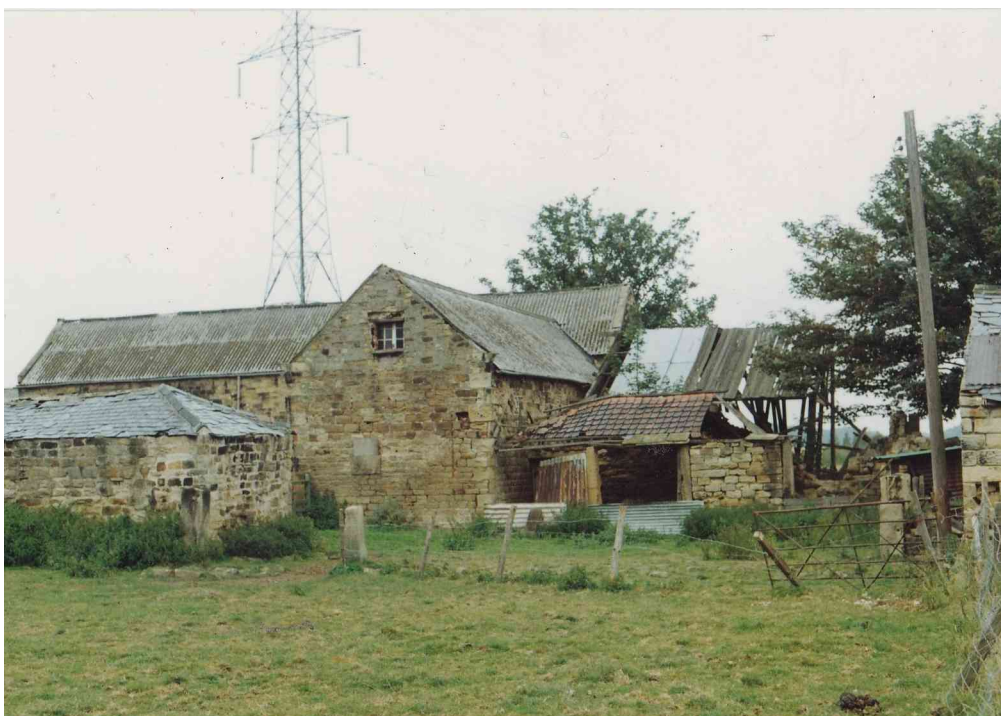
The W elevation at the N end is as it is today, though the windows and doors have been replaced. The window above the first stable door at this end had a wooden cill and 9-light casement window with narrow glazing bars. The window next to the door was of the louvre type seen in the store / piggery building. The door had a 2-part stable door as has its modern replacement. The dog house was under the steps up to the first floor. At eaves level the kneeler for what would have been a free standing gable is still in place. The second door has been blocked by stone except for a small opening. The third door has a cracked lintel which has now been replaced. Above it is a small taking-in door, now blocked. The fourth door is also partially blocked. It has a very weathered lintel, now replaced. Above is a small window: a tiny 9-light casement, now blocked.

The S gable has a small gable window with large (owl) resting ledge. Two six light casement windows are set in the inner wall opening.

The E elevation had an attached short wing at the S end and the shadow of it can be seen in the old photo. An older photo shows this to be a mainly open structure but with some stone walls and monolithic stone piers (fig.20). It had a pantile roof with stone slates for the last two courses. Above this was a window (blocked), then next to it a door (blocked, now open again). Then an upper floor window (blocked, new one inserted to the N of it) and a ground floor window with wooden lintel and sill (now much wider, part of a pair of doors). Beyond that there are no ground floor openings and only one more (blocked) upper floor opening.

*Figure 20: Stable block viewed from SW (1995)*

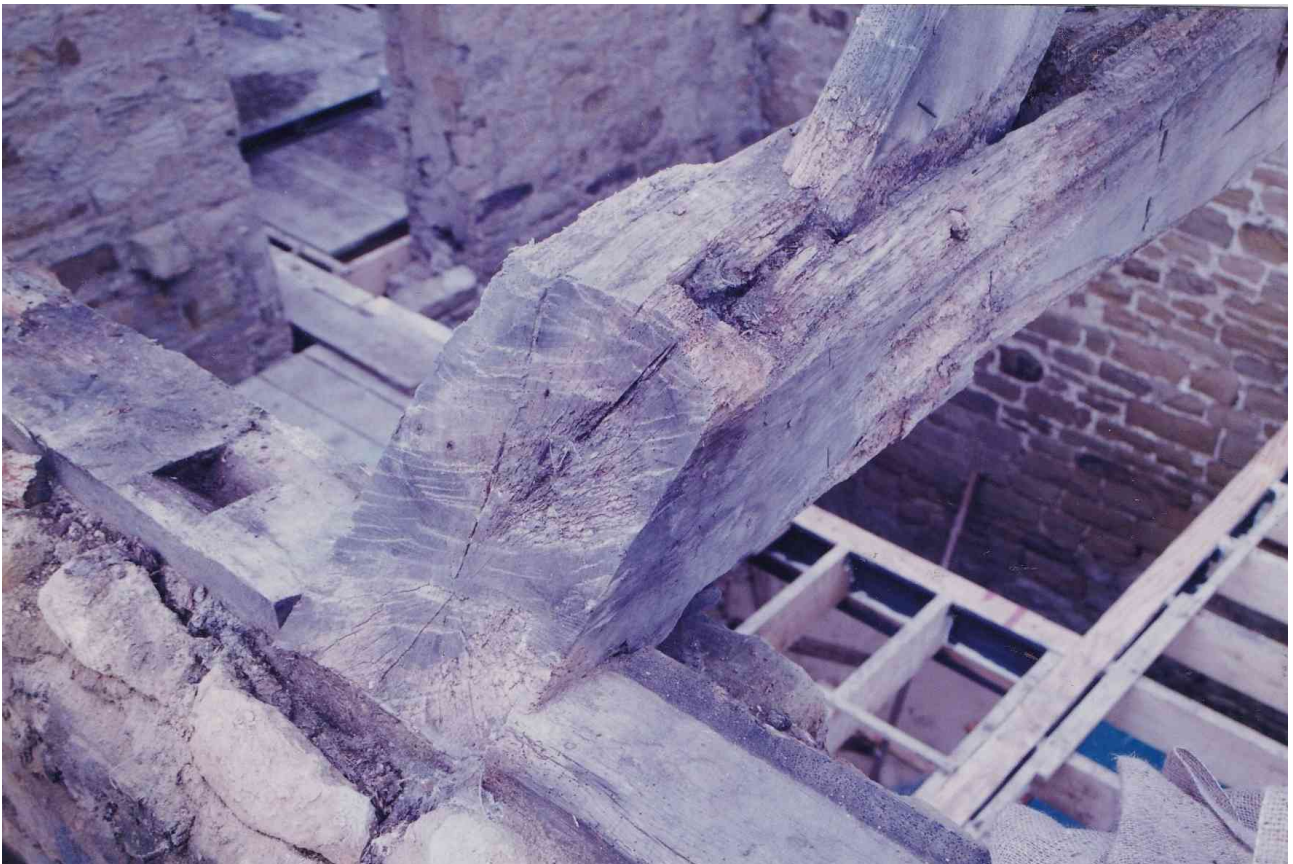
Roof: a photo from March 1997 shows it with the tiles off and the caption 'new oak principals'. A photo from 1995 shows the tie-end of one of these principal rafters (fig.21).

*Figure 21: Stable block: tie beam of principal rafter (1995)*
